Draft Cap Inspection Report for the Former Pacific Electric Motors Facility, 1009 66th Avenue, Oakland, California

1009 66TH AVENUE
OAKLAND, CALIFORNIA
CAP INSPECTION

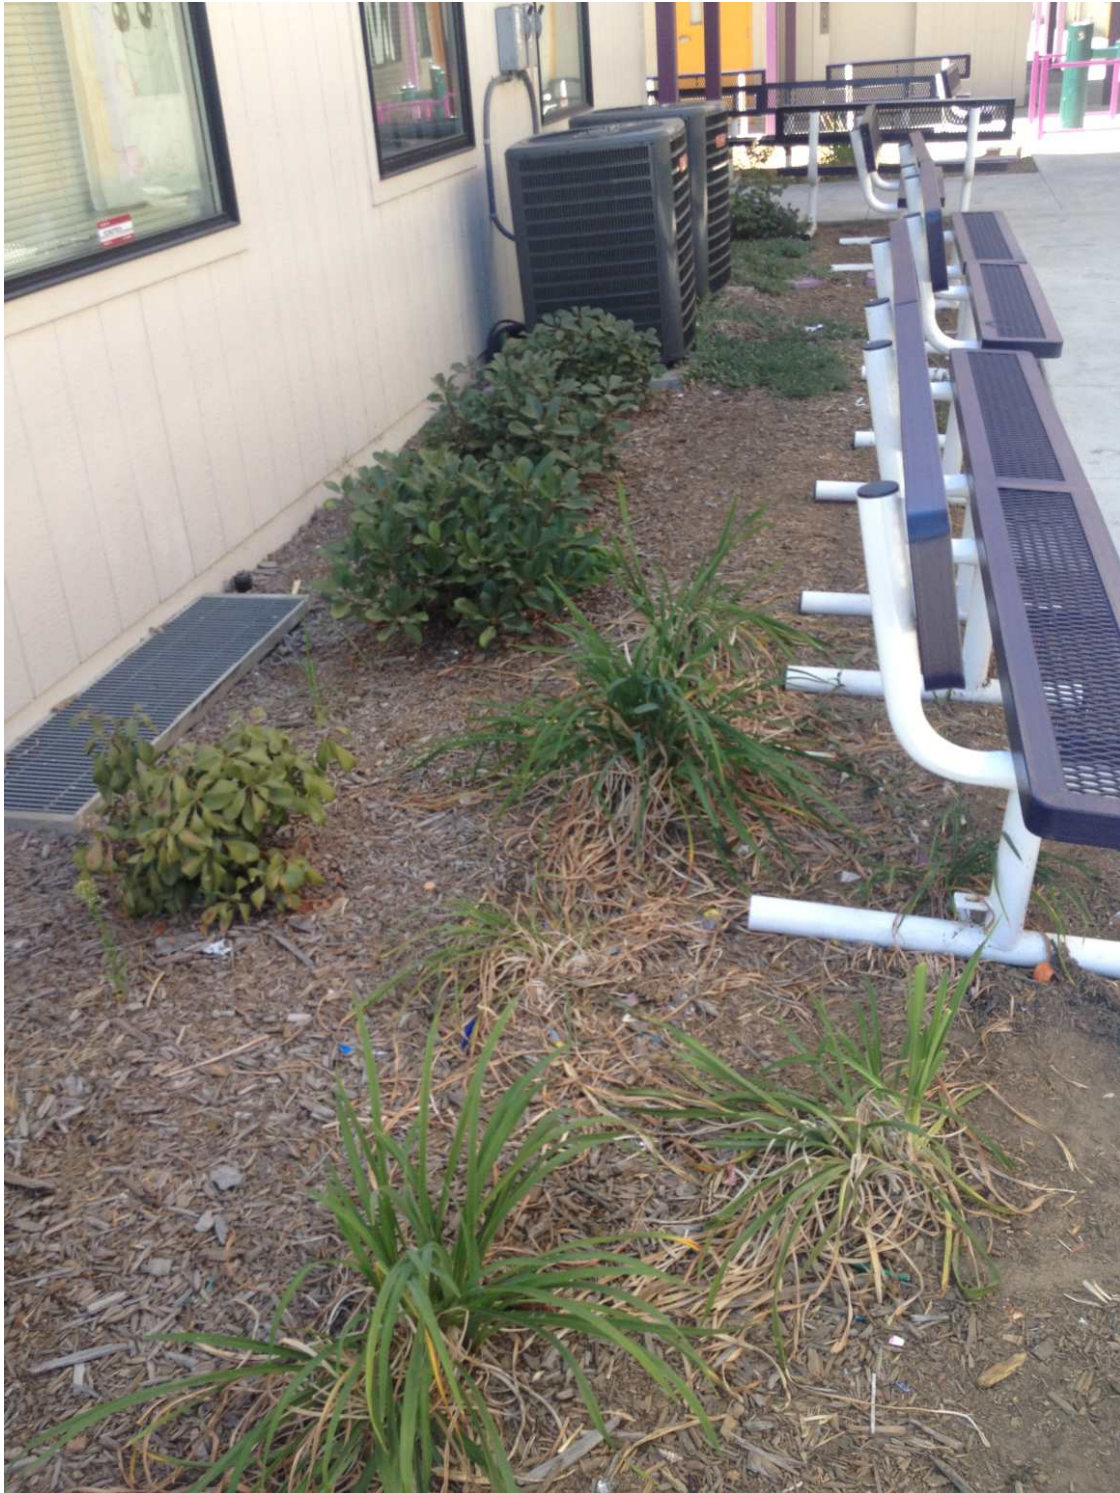
FIGURE
14

Landscaped Area in the Pedestrian Walkway - Courtyard Area-1

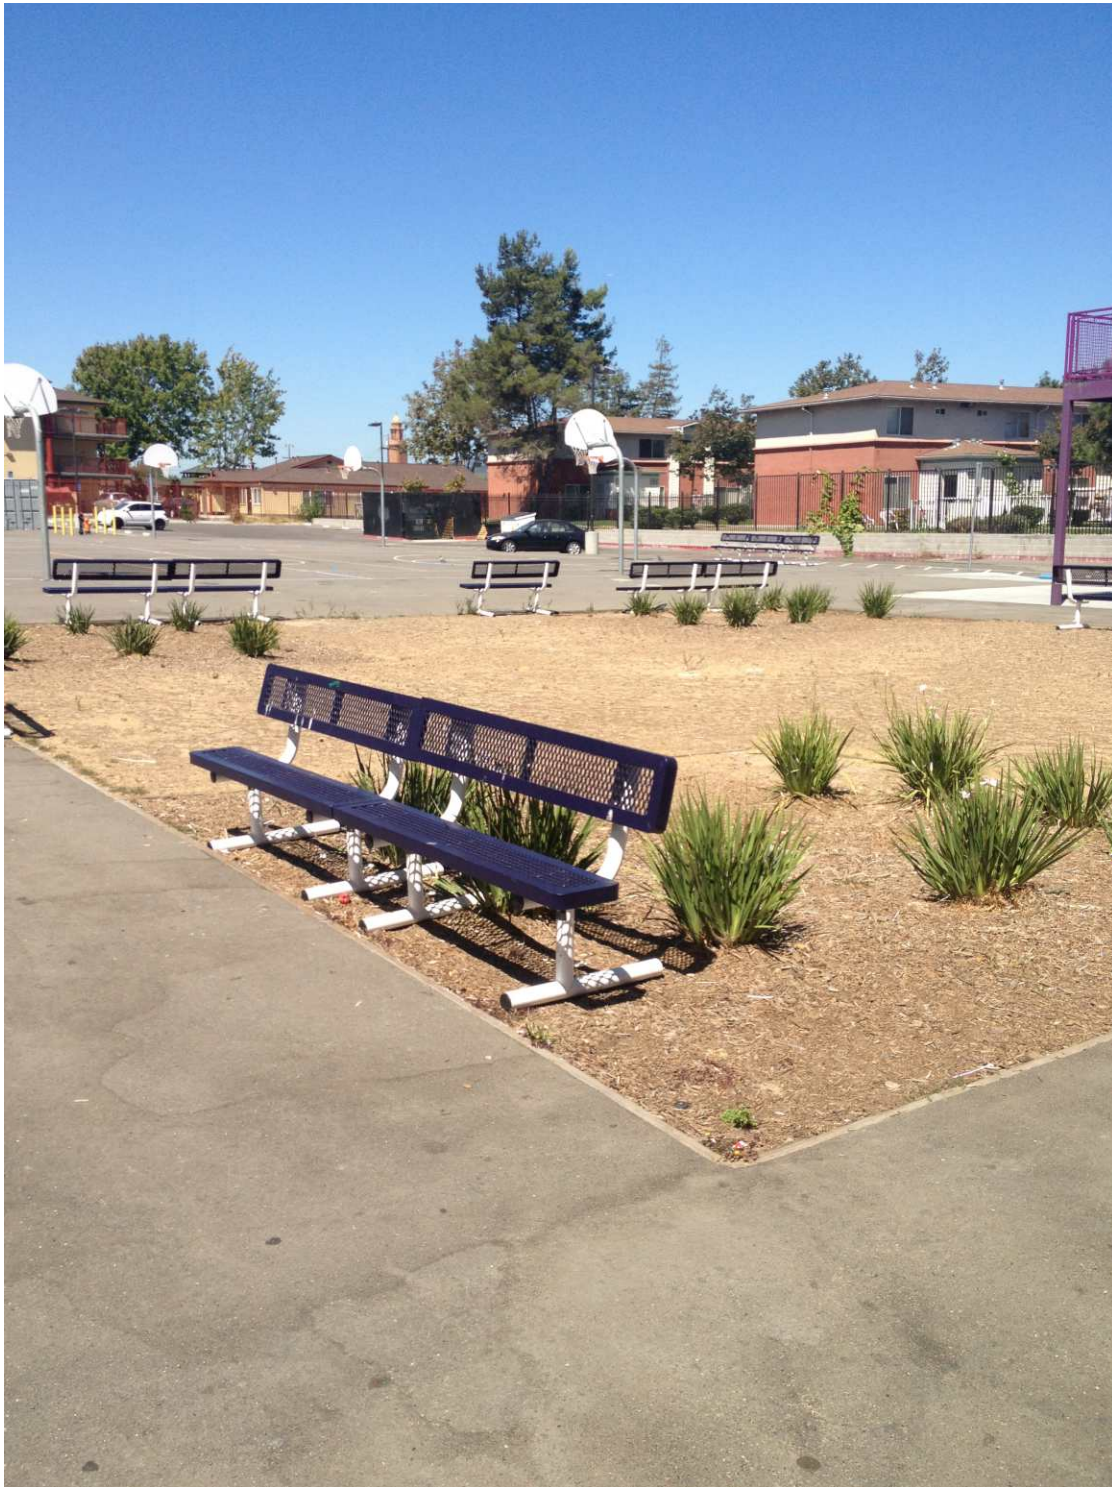
FIGURE
15

Landscaped-Planter and and Pedestrian Walkway Area Near the Rear
of the Site

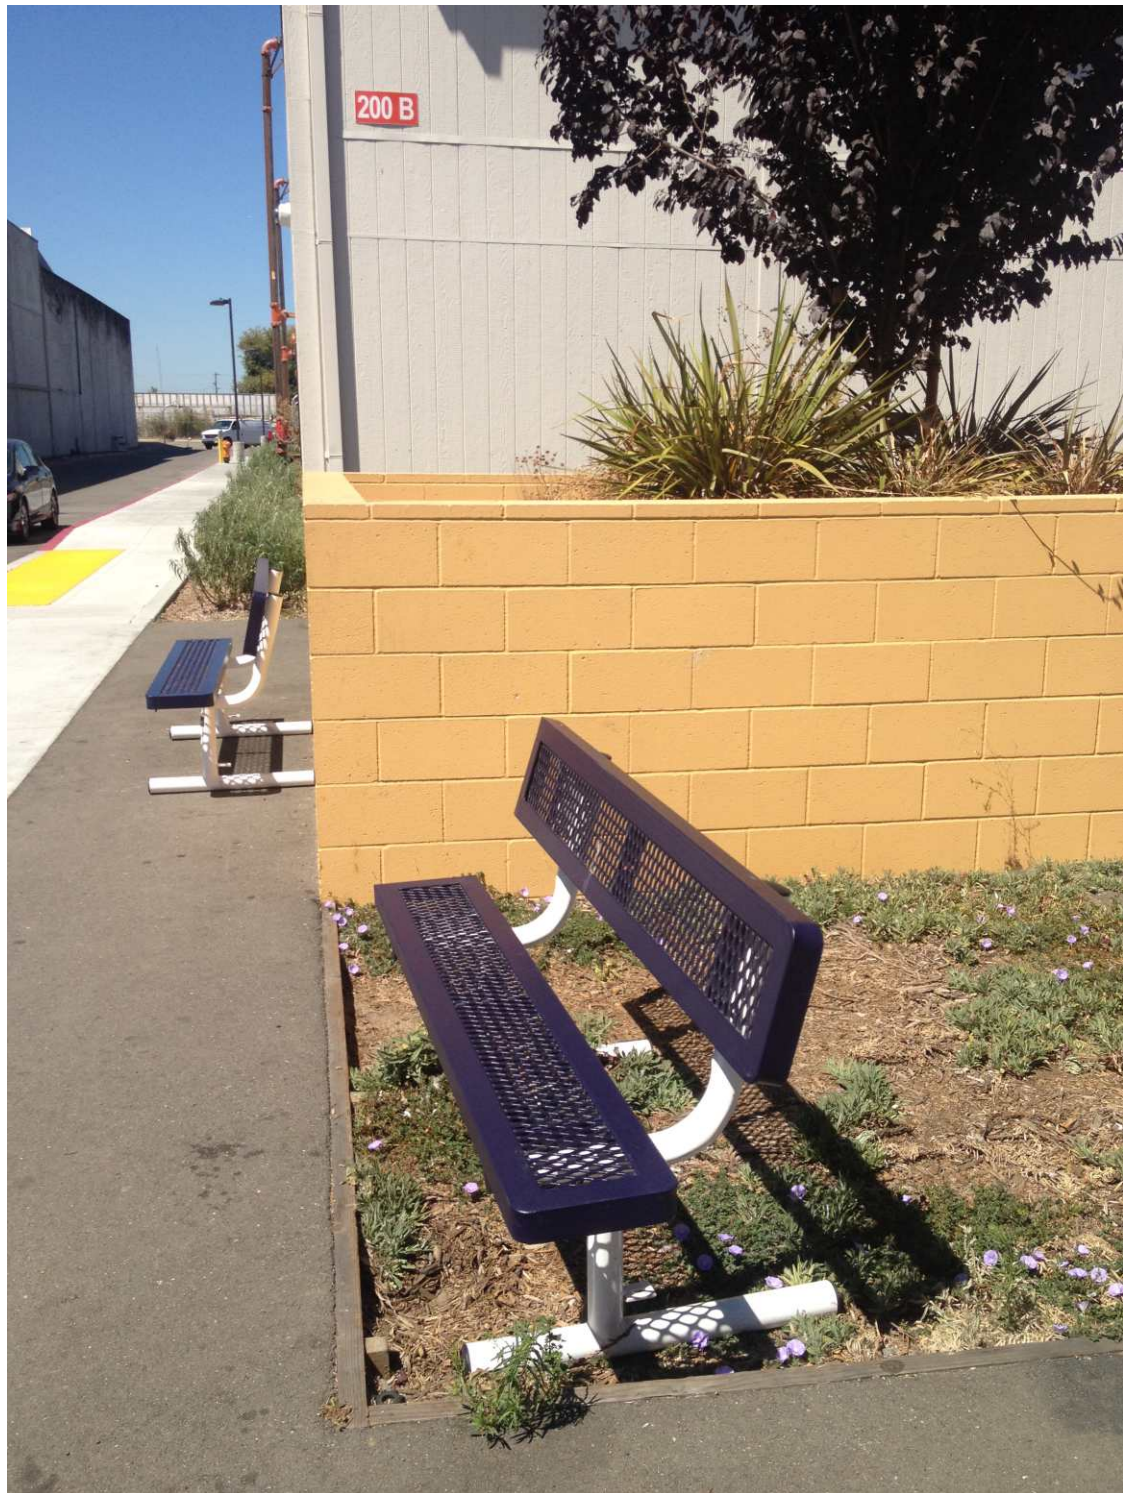
FIGURE
16

Landscaped-Planter and Pedestrian Walkway Area Near Classroom

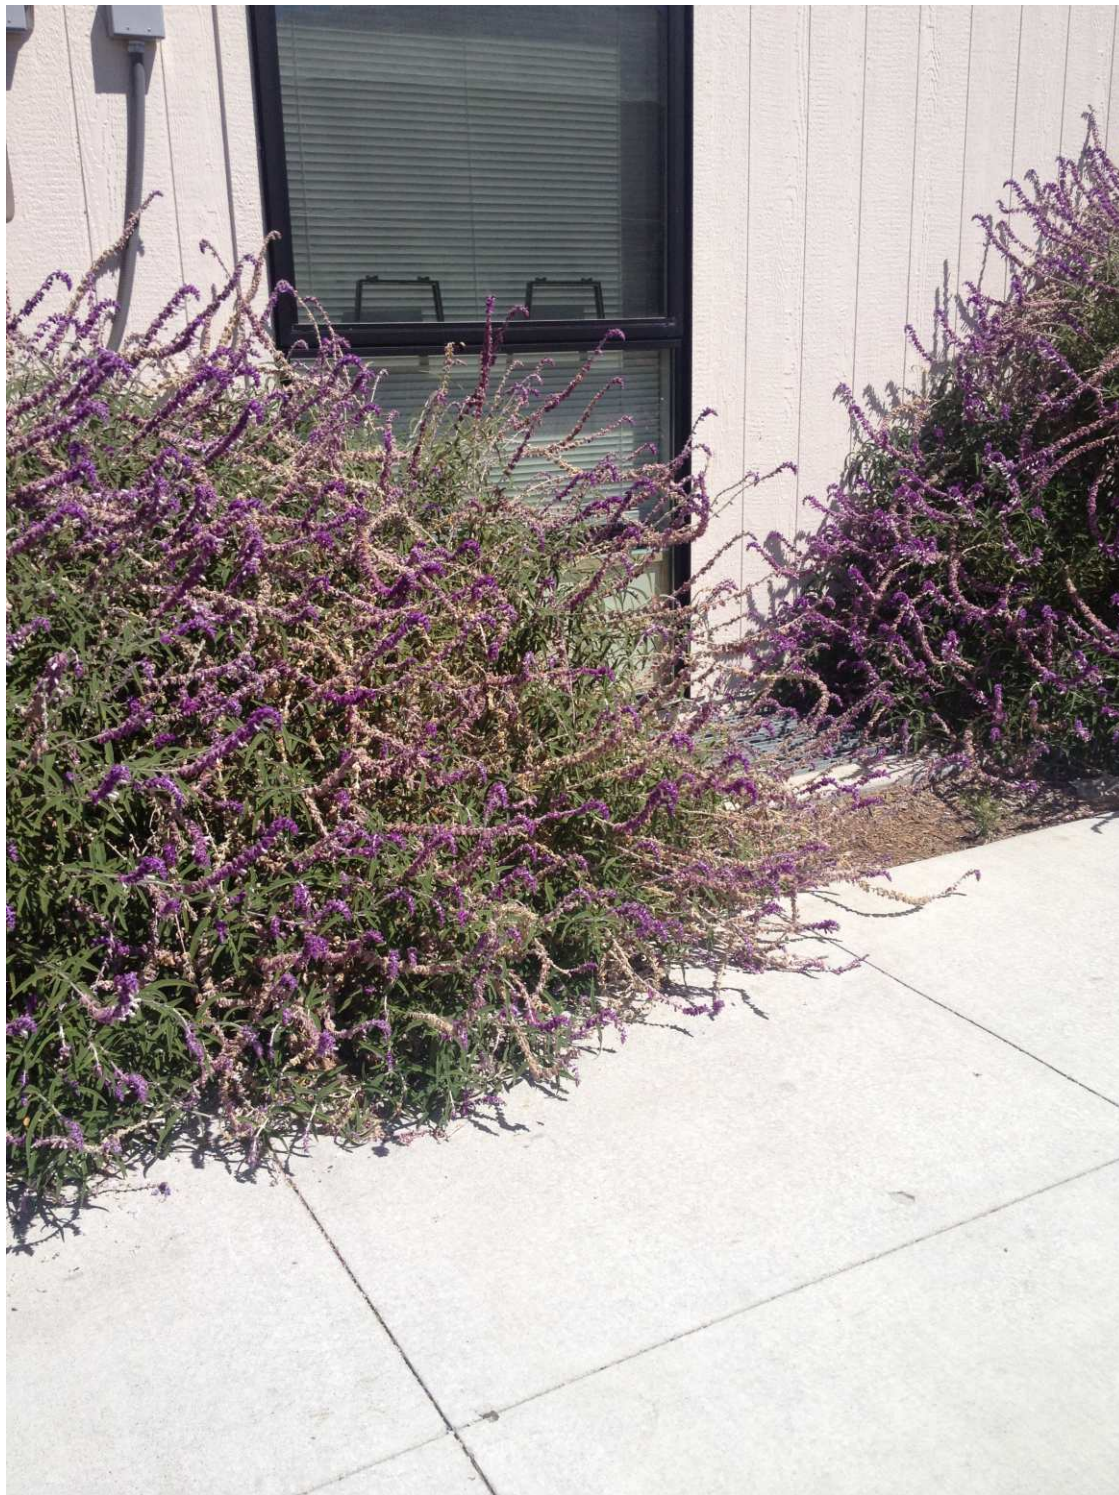
FIGURE
17

Landscaped-Planter Area Near Classroom

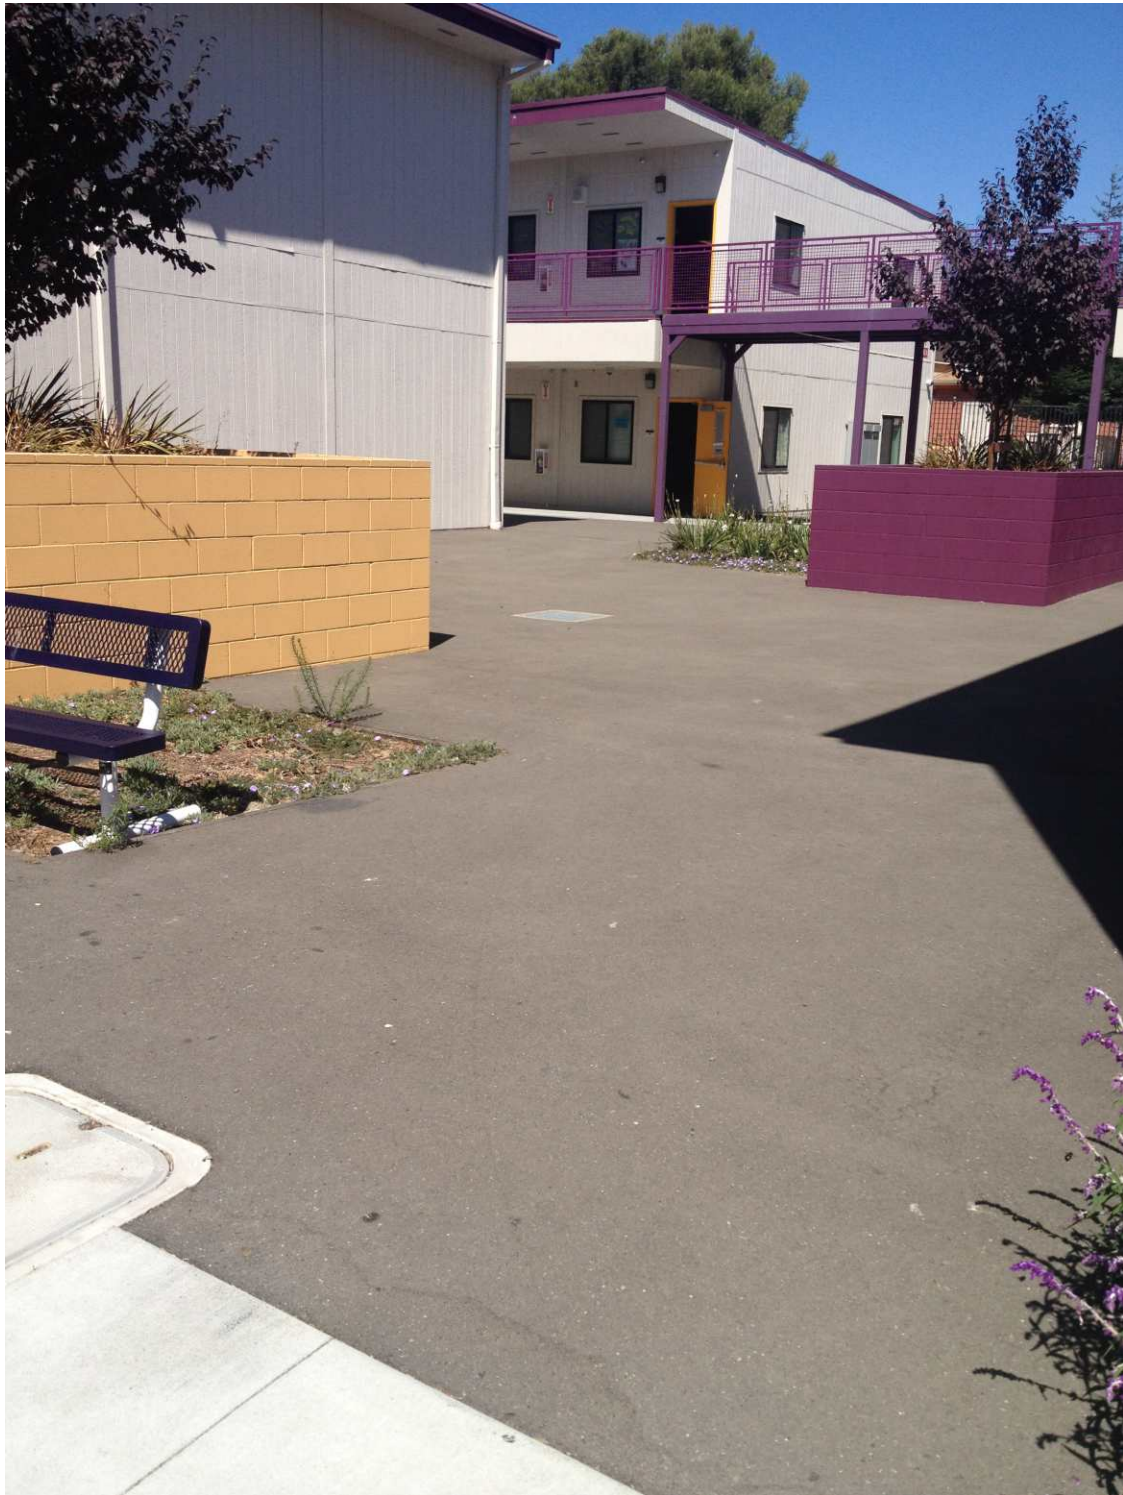
FIGURE
18

Pedestrian Walkway Area

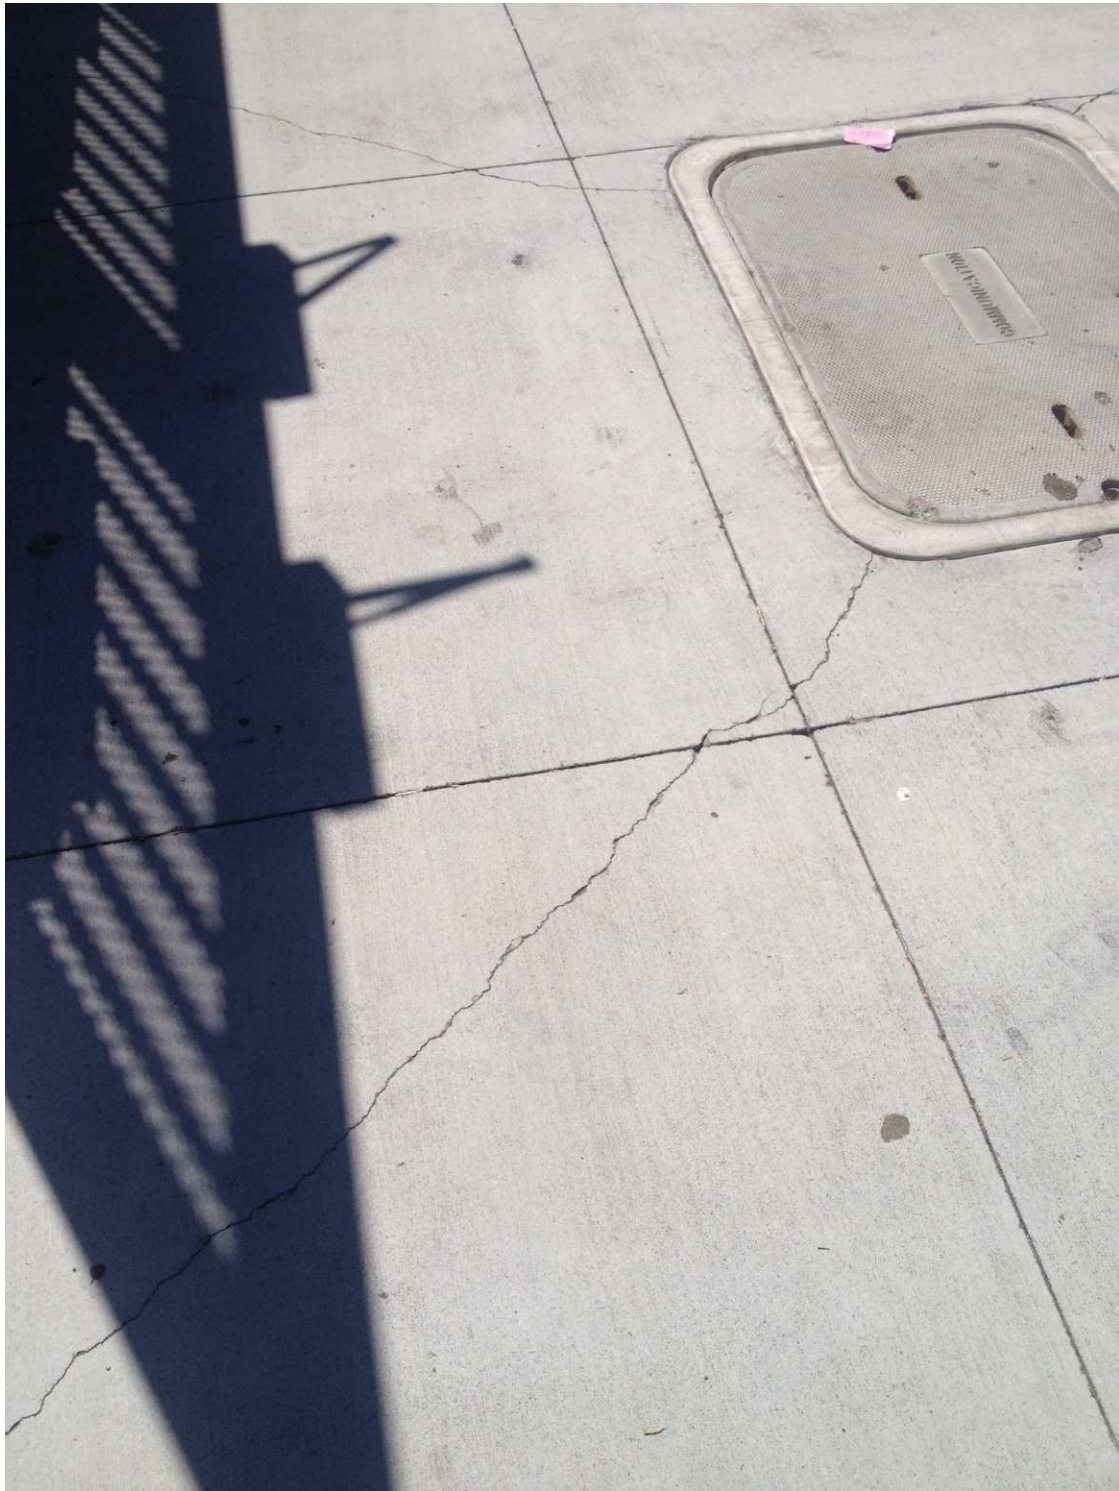
FIGURE
19

Minor Crack in Pedestrian walkway Area Near Office
